VIN: 3ALACWDT4FDGK6547

2015 FREIGHTLINER M2

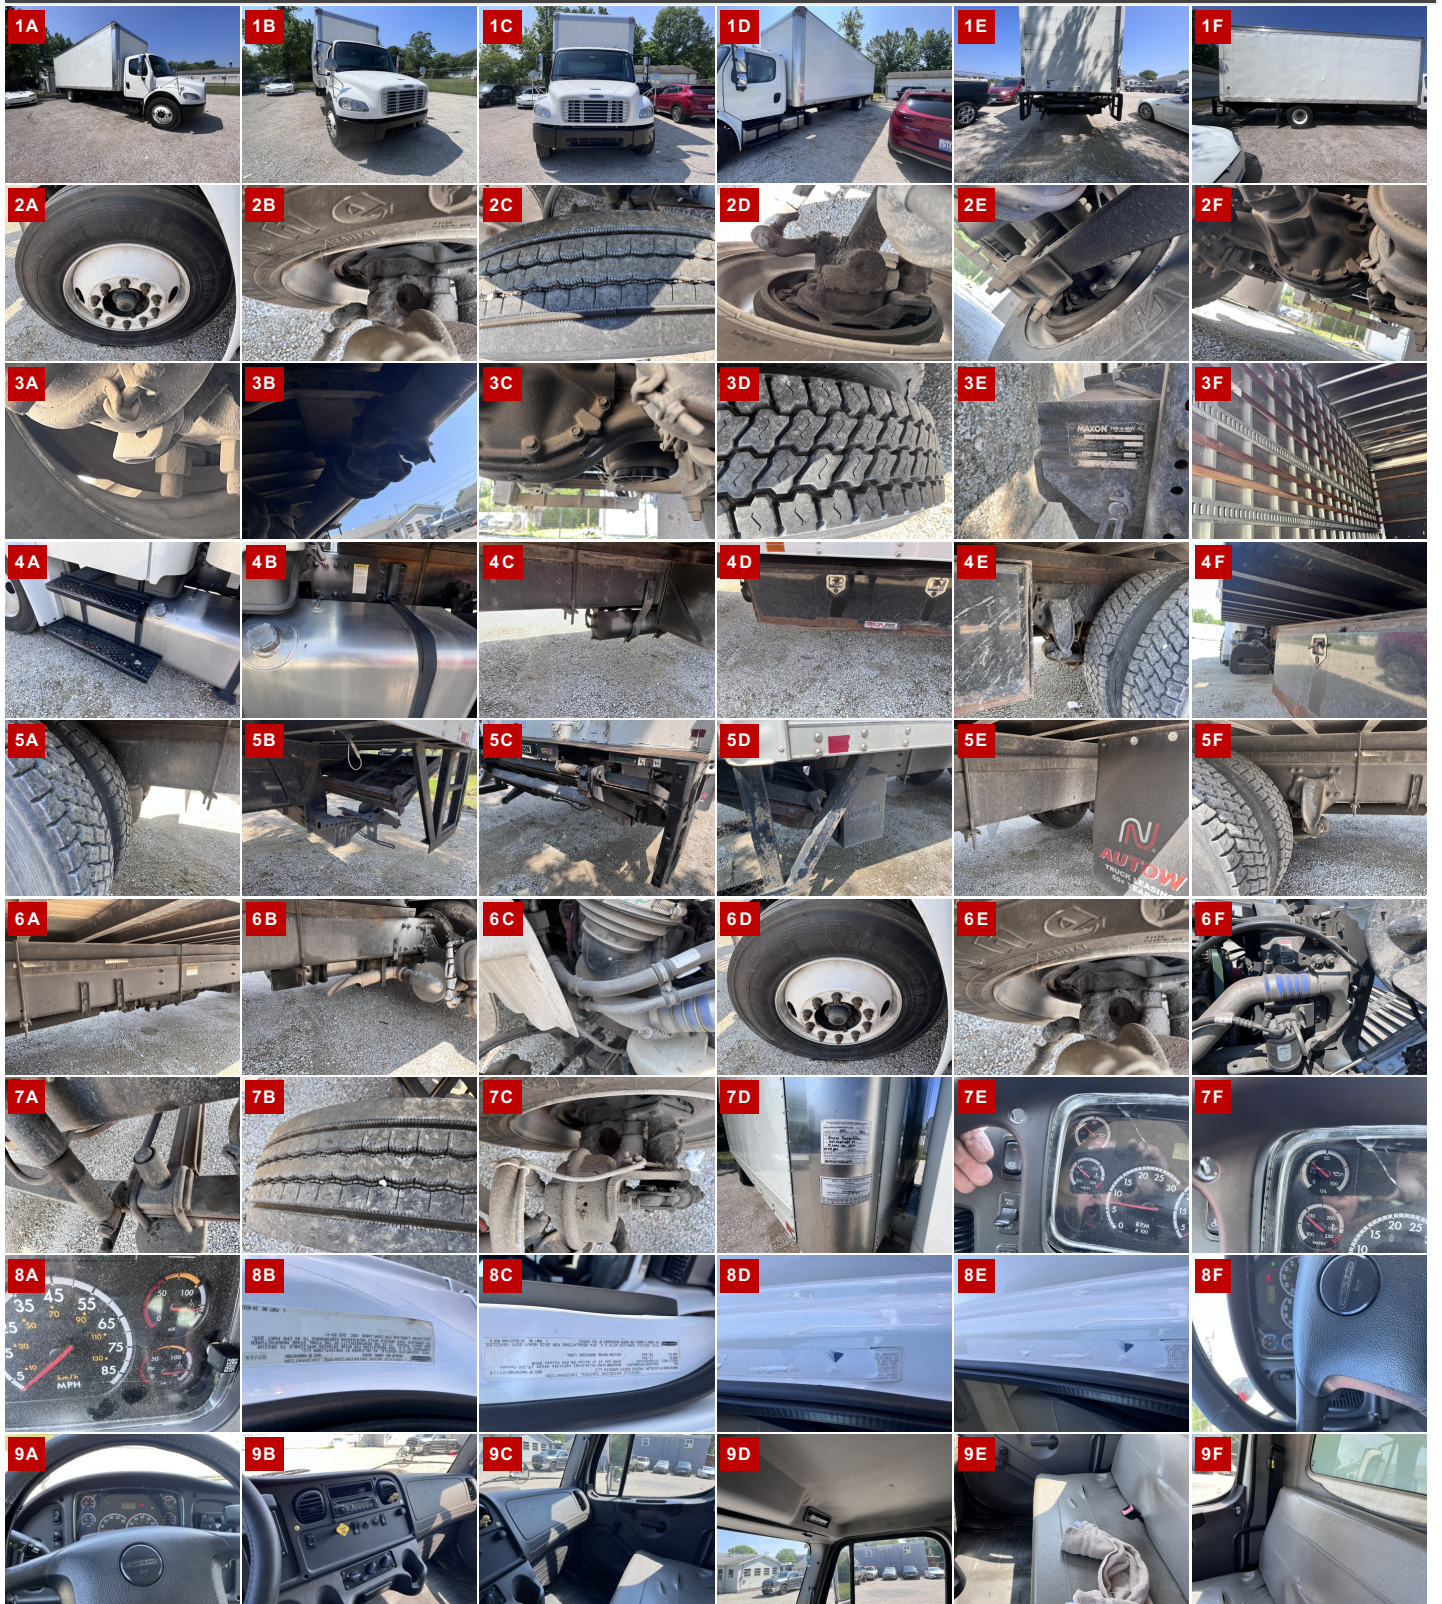
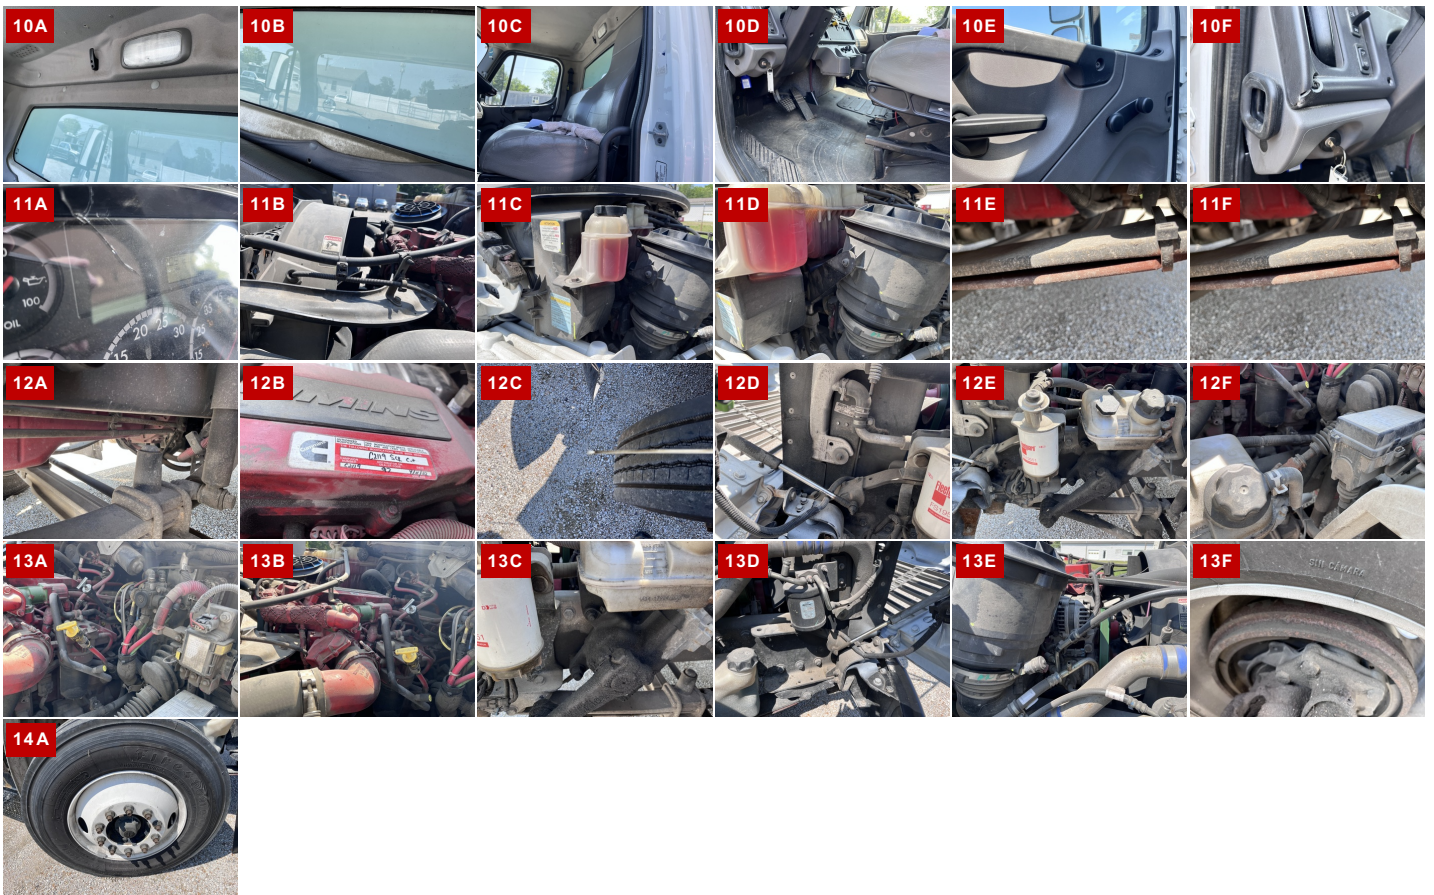
DIAGNOSTICS	UNABLE TO RETRIEVE FULL DATA ON SCAN (SEE ECM REPORT 1). NO WARNING INDICATORS ACTIVE AT DASH.
VAN BOX	RIGHT SIDE MANY DENTS AND LARGE CREASE AT THE TOP REAR WITH TWO PATCH REPAIRS. RIGHT REAR CORNER POST DENTED AT BOTTOM, LEFT SIDE HAS A FEW DENTS. FRONT LEFT CORNER OF VAN BOX HAS DAMAGE AT TOP
DOCK PLATE	REAR DOCK PLATE RIGHT SIDE STEPS ARE BENT.
POWER STEERING	GEARBOX LEAKING
DIFFERENTIAL	FLUID RESIDUE AT BOTTOM OF HOUSING
TOOL BOX	PAINT FLAKING AND RUST FORMING
SUSPENSION	STEER SHOCK LEAKING
PASSENGER SEAT	UPHOLSTERY IS TORN / CUT
INSTRUMENT CLUSTER	COVER IS CRACKED
HEADLINER	FABRIC IS DIRTY AND SAGGING.
